DEPARTMENT OF TRANSPORTATION

Quality Assurance and Source Inspection

Contract #: 04-0120F4Cty: SF/ALA Rte: 80 PM: 13.2/13.9File #: 1.28**WELDING INSPECTION REPORT****Resident Engineer:** Casey, William**Address:** 333 Burma Road**City:** Oakland, CA 94607**Report No:** WIR-027444**Date Inspected:** 12-Apr-2012**Project Name:** SAS Superstructure**OSM Arrival Time:** 700**Prime Contractor:** American Bridge/Fluor Enterprises, a JV**OSM Departure Time:** 1530**Contractor:** American Bridge/Fluor Enterprises, a JV**Location:** Job Site**CWI Name:** As noted below**CWI Present:** Yes No**Inspected CWI report:** Yes No N/A**Rod Oven in Use:** Yes No N/A**Electrode to specification:** Yes No N/A**Weld Procedures Followed:** Yes No N/A**Qualified Welders:** Yes No N/A**Verified Joint Fit-up:** Yes No N/A**Approved Drawings:** Yes No N/A**Approved WPS:** Yes No N/A**Delayed / Cancelled:** Yes No N/A**Bridge No:** 34-0006**Component:** SAS OBG**Summary of Items Observed:**

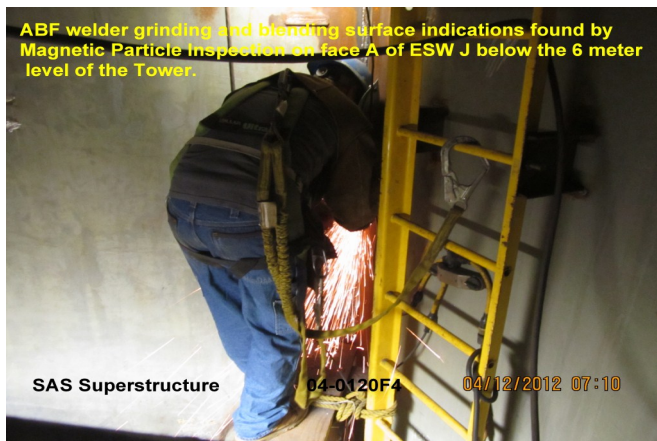
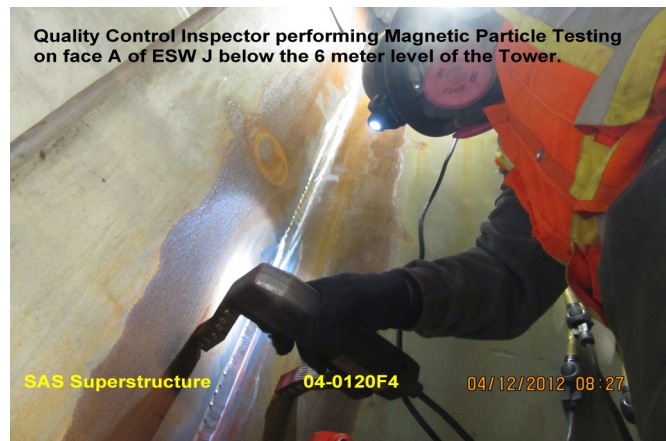
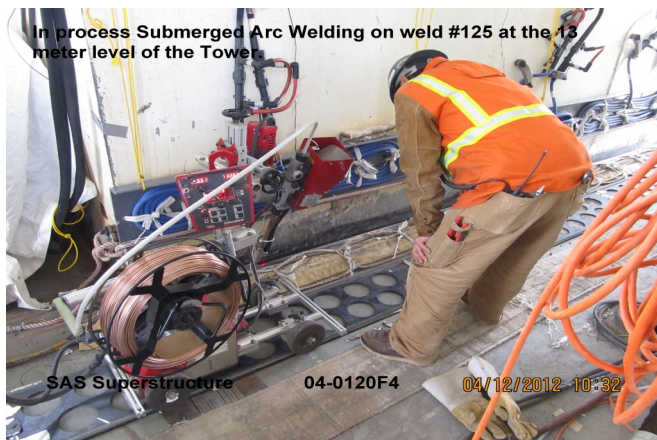
This QA Inspector made random observations of repair operations on Electroslag Weld (ESW) J face A below the 9M level of the Tower at 3300mm to 3650mm. ABF welder Richard Garcia (ID 5892) employed a small disc grinder to smooth and blend surface indications prior to performing SMAW in the 3G vertical position. The welder was observed operating with 3.2mm E7018-H4R electrodes obtained from a baking oven within the general vicinity. Mr. Garcia utilized a chipping hammer to remove the slag from the weld between passes and upon completion of the repair operations, employed a small disc grinder to remove excessive weld reinforcement to bring the repaired area to a flush surface condition. QC Inspector Jesse Cayabyab performed a Magnetic Particle (MT) Inspection of the area and found no rejectable indications at the time of testing. This QA Inspector performed an MT Inspection of face A of ESW J at 3300mm to 3650mm. This QA Inspector performed the yoke method in conformance with ASTM E 709 and the standard of acceptance with D1.5 section 6.26. This QA Inspector noted that no rejectable indications were found at the time of testing. This QA Inspector generated a TL-6028 MT report on this date. The completed work at this location appeared to be in general conformance with the contract specifications.

This QA Inspector reported to the 13M elevation of the Tower to monitor quality and observe Submerged Arc Welding (SAW) of the diaphragm plate weld #125. This QA Inspector observed heat induction blankets to provide pre-heat for the single bevel joint and verified the temperature was the required minimum of 225° F. It was also noted that the remote oven for the ESAB EN 760 Flux was in the on position with the dial set at 250° F as ABF welding personnel employed a flux recycling vacuum hose to empty the feeder hopper of the SAW unit. This QA Inspector observed the removal of the electrode spool which was discarded and replaced with a new F7A2-EM12KH8 electrode spool. QC Inspector Fred Von Hoff measured the parameters for amperage, volts, travel speed and the heat input as ABF welder James Zhen (ID 6001) adjusted the controls on the Lincoln track mounted wire feeder. Upon approval for conformity with WPS-D1.5-4062-1, Mr. Zhen commenced welding operations on weld #125 in the 1G flat position. On a subsequent observation, this QA Inspector observed ABF welding personnel recycle the flux utilizing a vacuum hose and cleaning the edge of the work with a chipping hammer between passes. Mr. Zhen was observed adjusting the path of the feeder prior to each consecutive pass during the ongoing process and inspected each completed pass for indications and workmanship. QC Inspector Fred Von Hoff was present to monitor the welding and the parameters so they remain within the requirements of the WPS. This QA Inspector made subsequent observations throughout the shift to monitor quality and noted that the work was in progress and appeared to be in general conformance with the contract documents.
